# The IMO Resolution A.800 (19) luxury cabin fire test procedure

Test experience and suggested revisions

**SP Sveriges Provnings- och  
Forskningsinstitut**  
SP Rapport 2003:01  
ISBN 91-7848-927-X  
ISSN 0284-5172  
Borås 2003

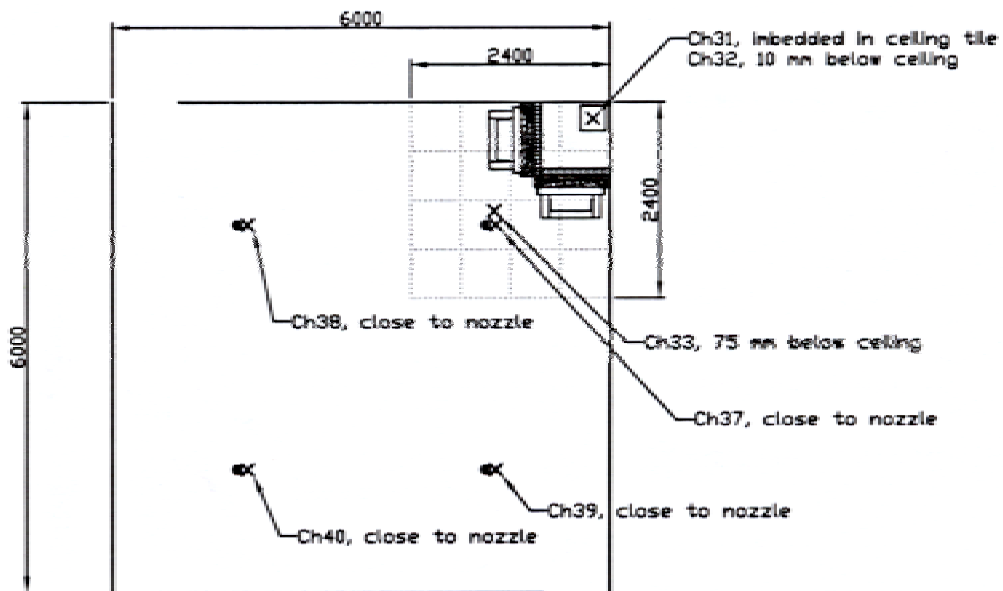
*Figure 1 A schematic drawing of the luxury cabin, the position of the nozzles and the instrumentation.*

The luxury cabin set-up is shown in figure 1.

During the tests, the ceiling material and ceiling gas temperatures were measured above the ignition point and at the nozzle closest to the ignition point. In addition to the measurement positions required by the test procedures, additional thermocouples were used to provide enhanced information of the performance of the tested system. All the measurement positions and the associated channels used are shown in the table below and in figure 1.

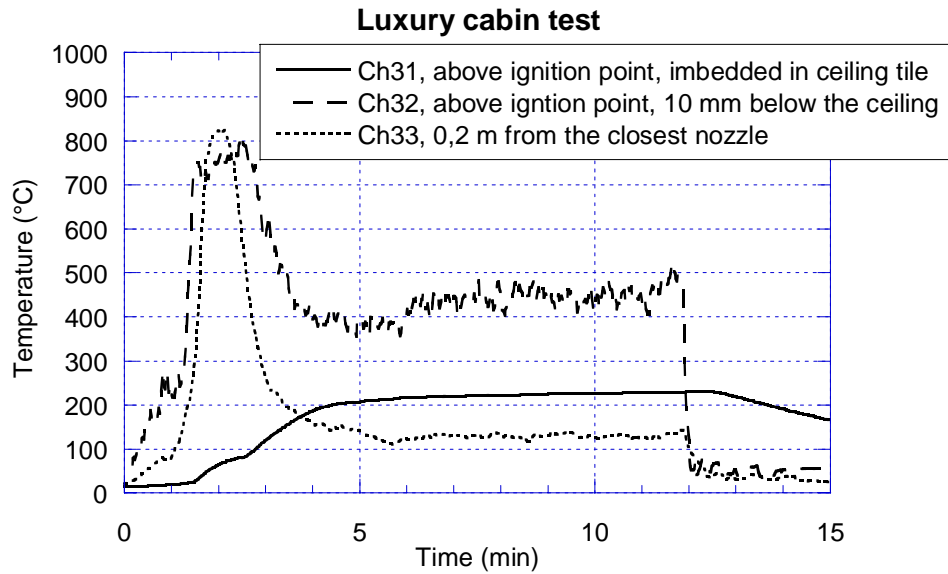
Figure A-1 Ceiling material and ceiling gas temperatures measured above the point of ignition as well as the gas temperatures measured at 0,2 m from the nozzle closest to the corner.

The ceiling material temperature directly above the fire source (Ch31) peaked at 232°C, i.e. the acceptance criteria was met. Comparing the material temperature with the ceiling gas temperature (Ch32) at the same position, indicate a dramatic difference, the ceiling gas temperature peaked at 807°C.

The ceiling gas temperature measured at a horizontal distance of 0,2 m from the nozzle closest to the fire (Ch33) peaked at 828°C, which is far in excess of the acceptance criteria. However, the water spray from the nozzle did not affect this thermocouple. From the measurements described above, it is obvious that the temperature would have been limited if this thermocouple had been positioned such that it had been directly affected by the water spray from the nozzle.

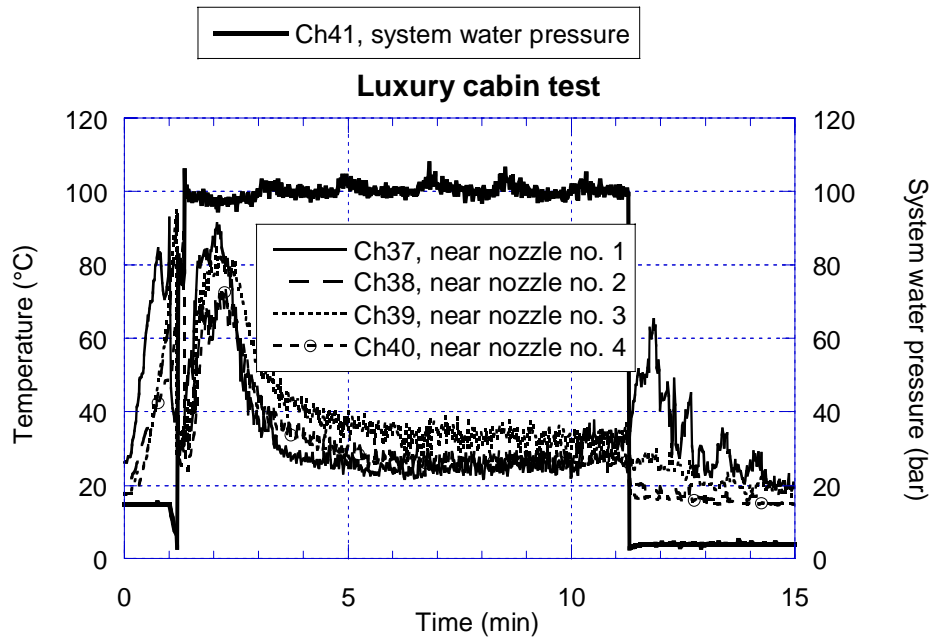
Figure A-2 Gas temperatures measured close to each of the water mist nozzles and the system water pressure. Note the different scale on the y-axis compared to figure A-1.

All four nozzles activated at gas temperatures of between 89°C and 95°C, and, as these thermocouples were positioned inside the spray pattern of the actual nozzle, the temperatures were limited to the temperatures measured upon activation.

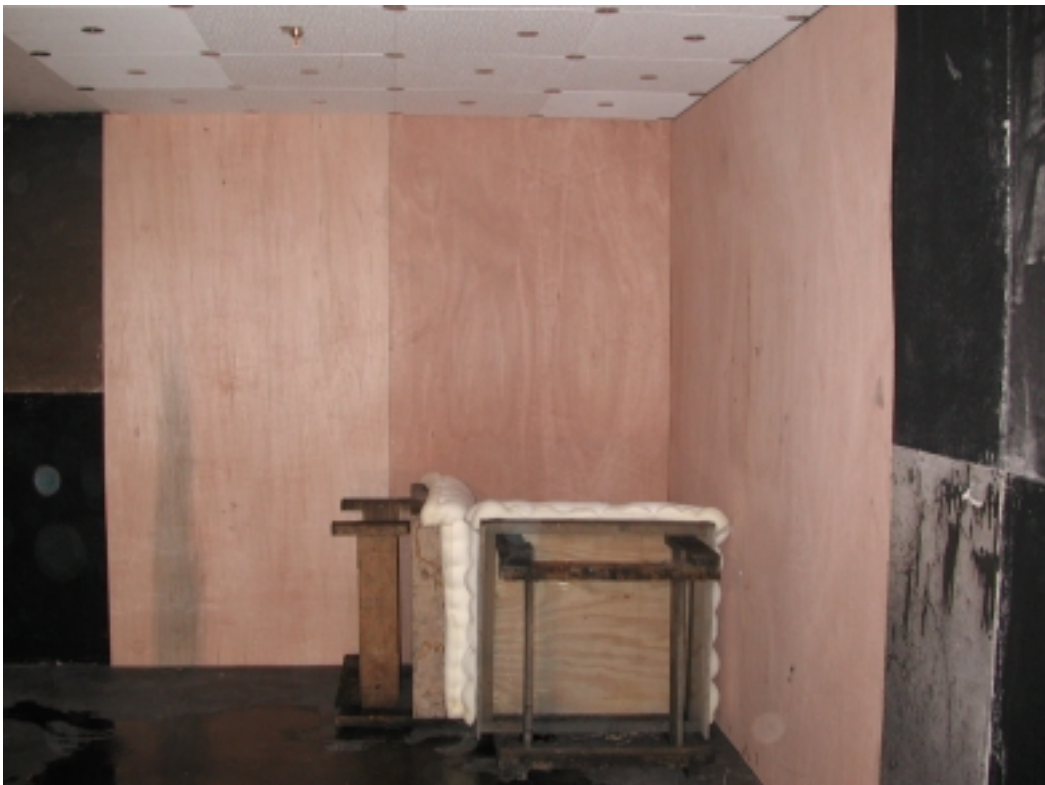
*Figure A-4 The luxury cabin prior to the test. The photo shows the position of the nozzle closest to the corner.*

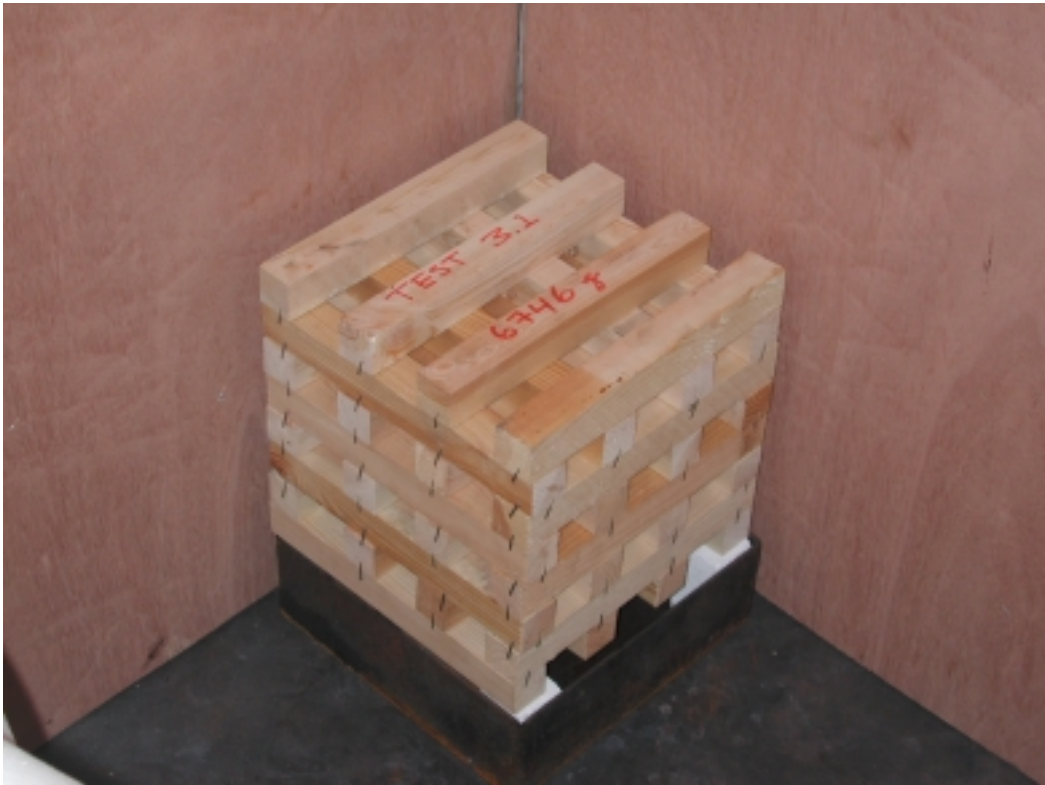
*Figure A-5 Close up picture of the wooden crib positioned on top of the pan with n-heptane.*

The fire source consisted of a wood crib and simulated furniture. The wooden crib weighed approximately 6,7 kg, i.e. slightly in excess of the stipulated weight of 6 kg, and consisted of eight alternate layers of four trade size 38 mm by 38 mm nominal by 305 mm long, evenly spaced, kiln-dried spruce wood members. The wooden crib was

oven dried prior to the test to reduce the moisture content to less than 5% and was placed over a 305 mm by 305 mm by 102 mm deep steel pan, supported by small non-combustible blocks at each corner of the pan. The pan was filled with 200 mL n-heptane over a 5 mm (465 mL) water base.

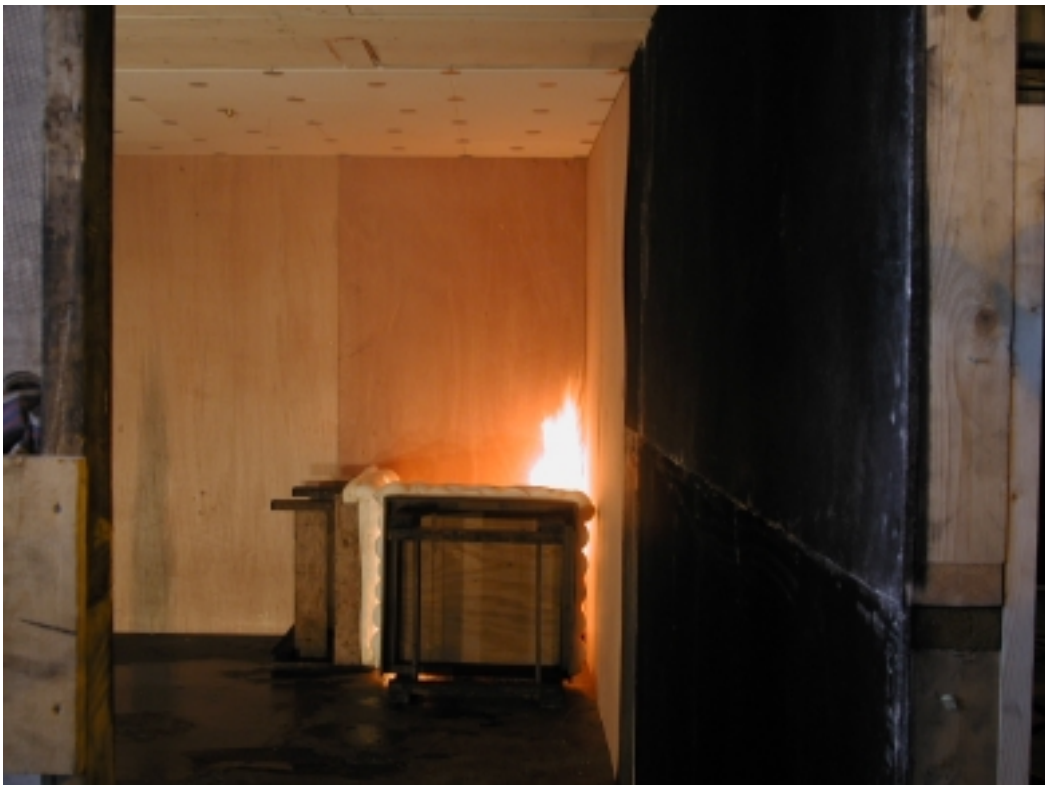
*Figure A-6 The fire size slightly after the ignition of the excelsior (wood wool).*

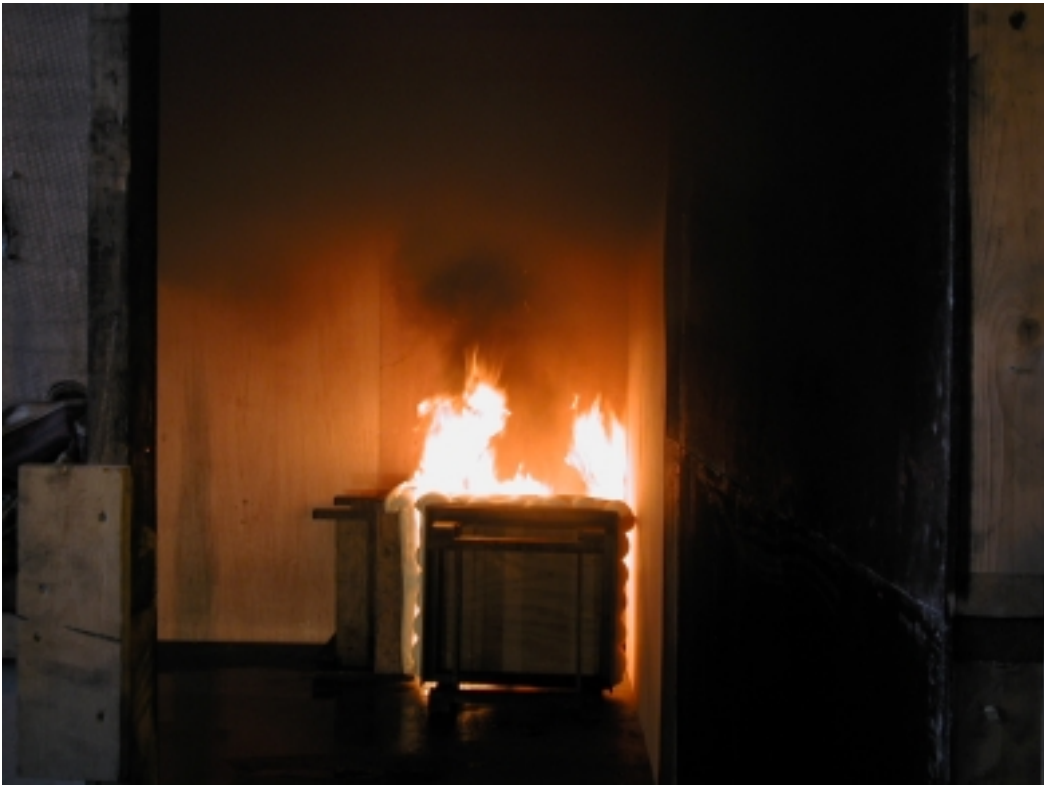
*Figure A-7 The fire size prior to the full fire involvement of the polyether foam cushions.*

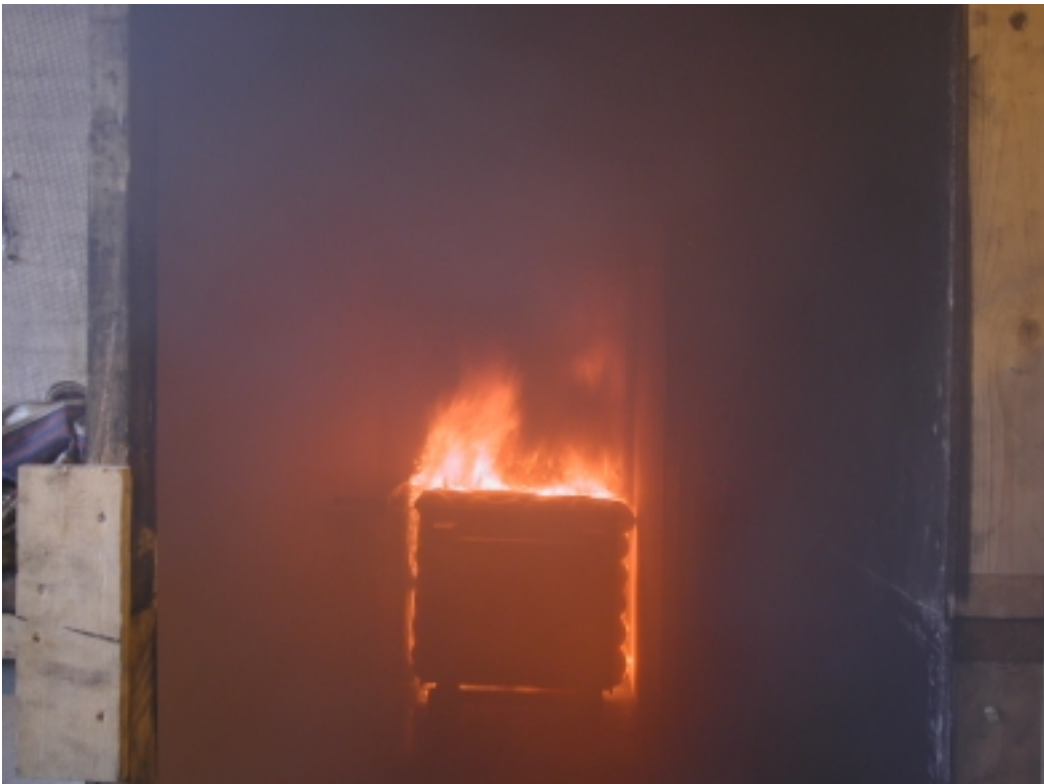
*Figure A-8 The fire size at the activation of the first nozzle.*

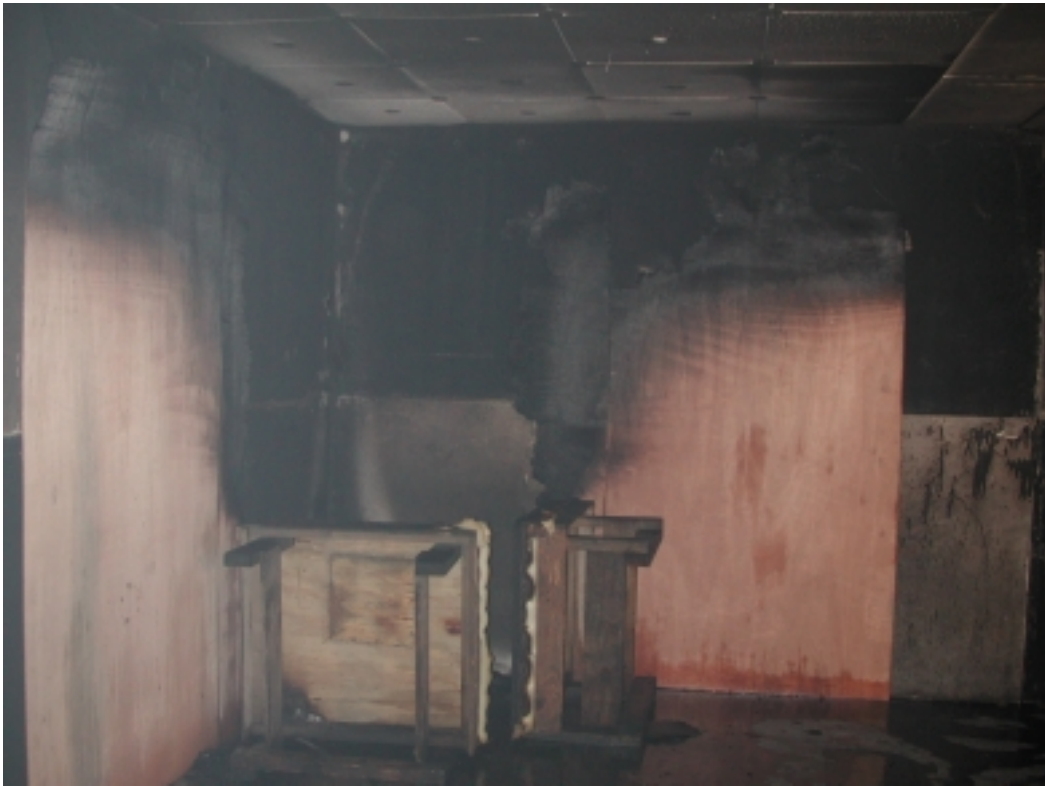
*Figure A-9 The luxury cabin after the test.*

The damages to the fire source was very severe, the fire consumed all the polyether foam of the simulated furniture and most of the wood crib. The two plywood panels positioned closest to the corner were almost completely consumed, only a small area, approximately 200 mm – 300 mm wide, at the position right beside the sides of the simulated furniture remained undamaged. The plywood panels adjacent to the corner panels were consumed in a pattern, measured from the ceiling, that was 700 mm – 400 mm high (right hand side) and 300 mm – 100 mm high (left hand side). In addition, both these plywood panels were severely burnt.

The ceiling tiles were not damaged but very sooty.

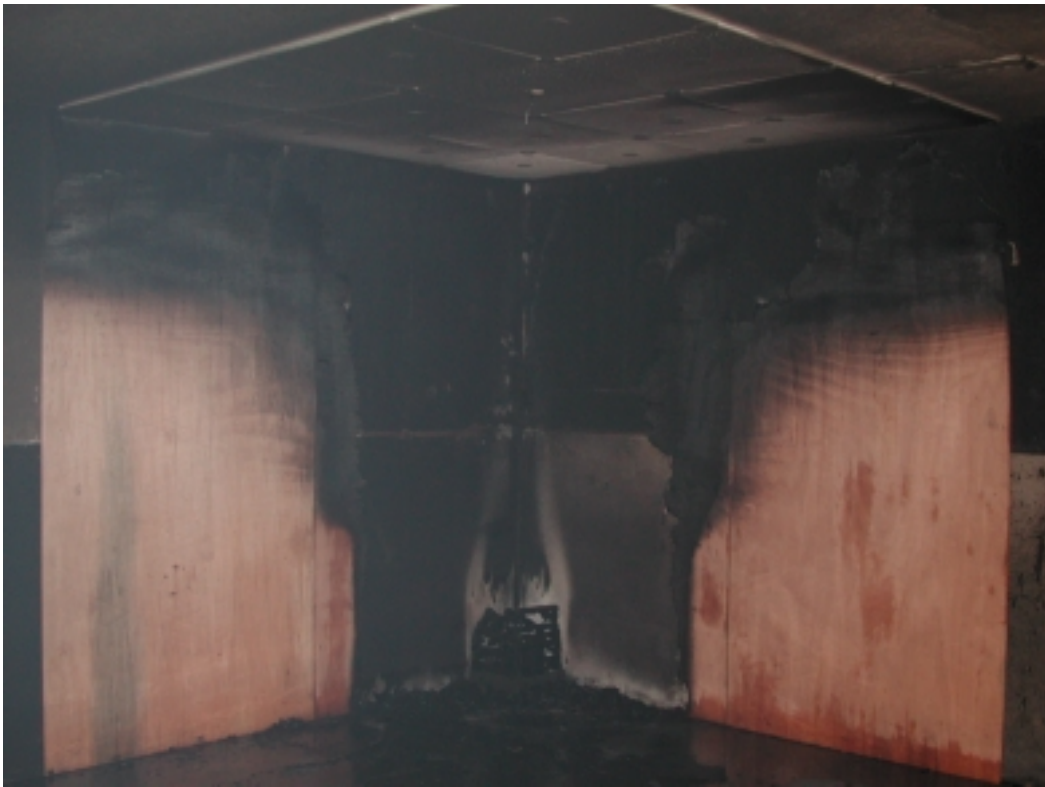
*Figure A-10 The luxury cabin after the test, with the 'simulated furniture' removed.*
